# **SITE RE-ASSESSMENT / PRE- CERCLIS SITE SCREENING / DESK TOP REVIEW REPORTS**

Former St. Louis Lead and Zinc Smelters and  
Processing Sites  
St. Louis, Missouri

August 31, 2006

Missouri Department of Natural Resources  
Division of Environmental Quality  
Hazardous Waste Program

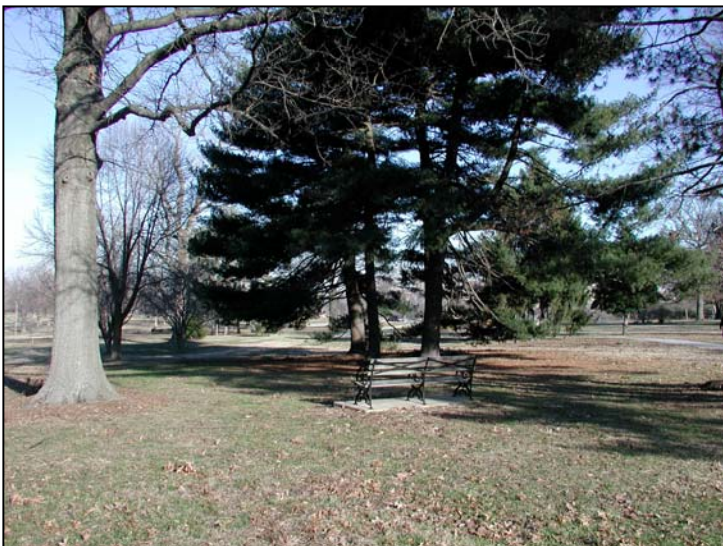
**Photograph 4**

Forest Park, view of Forest Park sampling  
location 2. View is facing east from Union  
Drive. This sampling location is east of the  
St. Louis Zoo and north of Interstate  
64/Highway 40 and approximately 100 yards  
north of the Jewel Box.

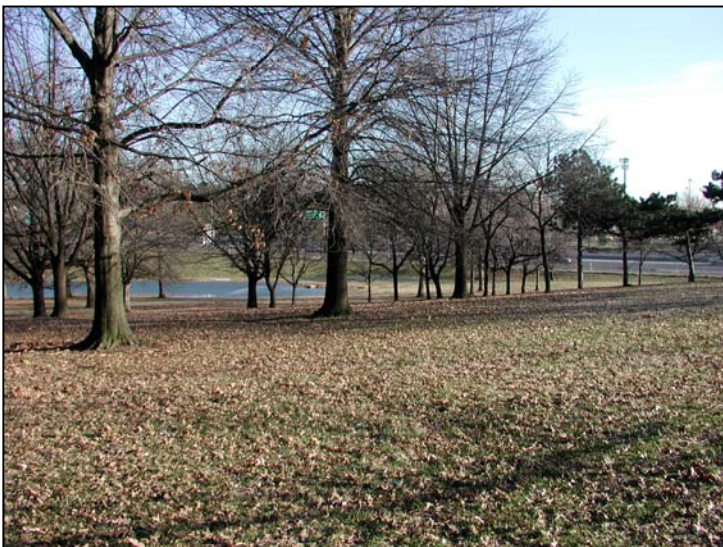
**Photograph 5**

Forest Park, view of Forest Park sampling  
location 2. View is facing southeast from  
east side of the St. Louis Science Center  
Planetarium. This sampling location is east  
of the St. Louis Zoo and north of Interstate  
64/Highway 40.

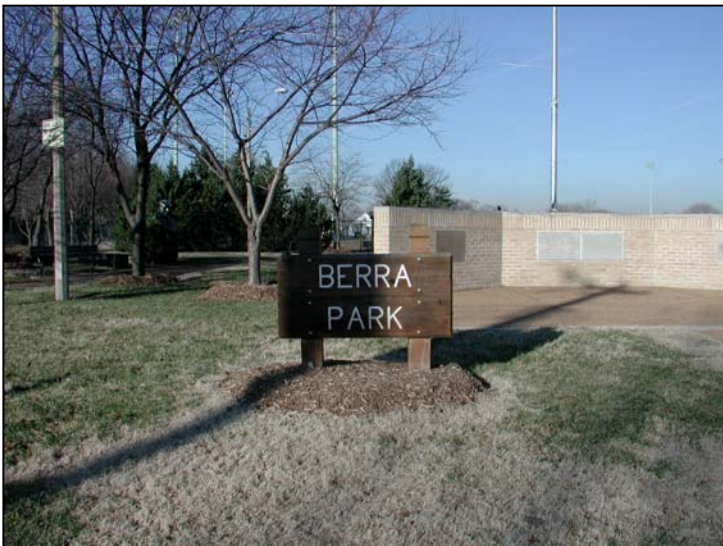
**Photograph 6**

Berra Park, view of Berra Park sampling  
location 4. View is facing west from  
Macklind Road.

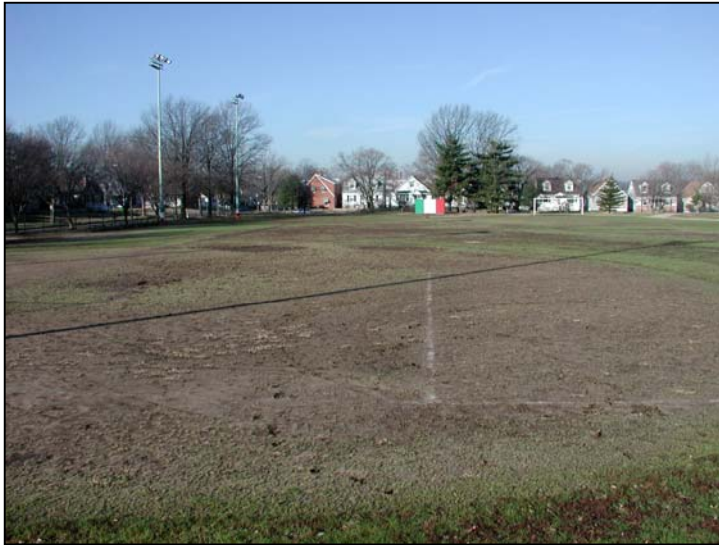
**Photograph 7**

Berra Park, view of Berra Park sampling location 4. View is facing east from Macklind Road side of park.

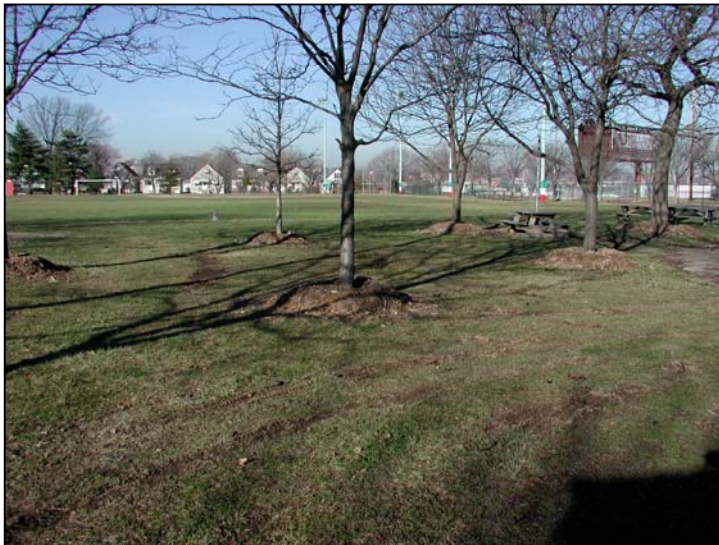
**Photograph 8**

Berra Park, view of Berra Park sampling location 4. View is facing east from Macklind Road side of park.

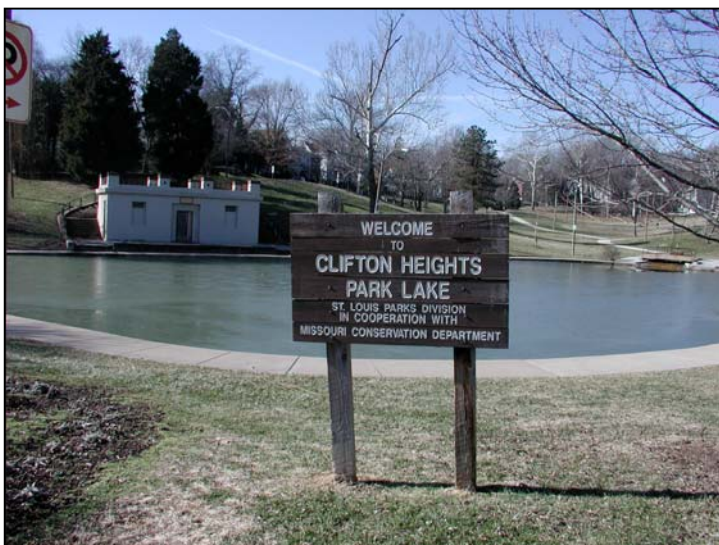
**Photograph 9**

Clifton Heights Park, view of Clifton Heights Park sampling location 5. View is facing west from Simpson Avenue side of park. Clifton Park is located approximately 1/4 mile south of Interstate 44 and is located the St. Louis neighborhood known as The Hill.

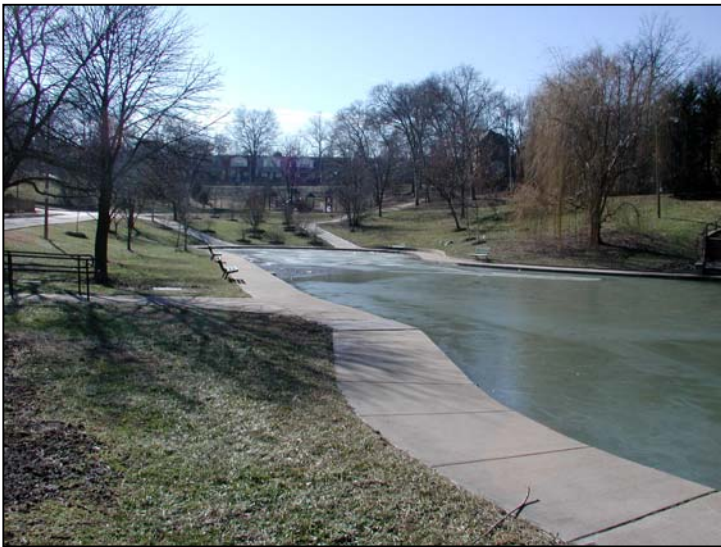
**Photograph 10**

Clifton Heights Park, view of Clifton Heights  
Park sampling location 5. View is facing  
west from Simpson Avenue side of park.

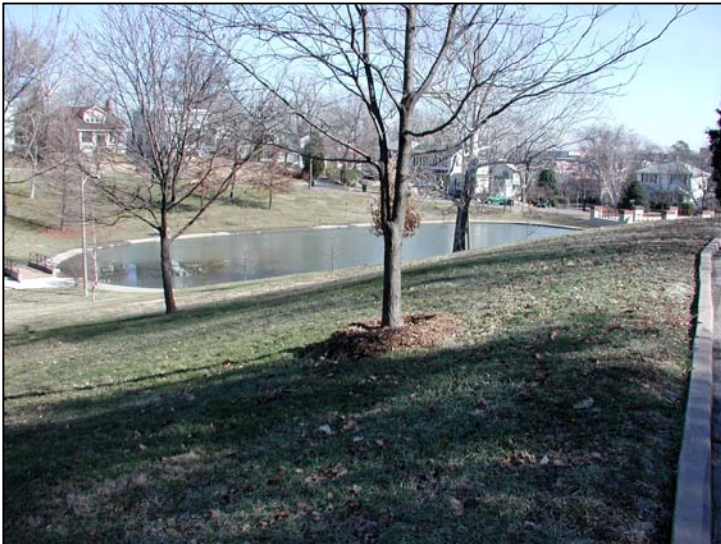
**Photograph 11**

Clifton Heights Park, view of Clifton Heights  
Park sampling location 5. View is facing  
southeast from Esther Avenue side of park.

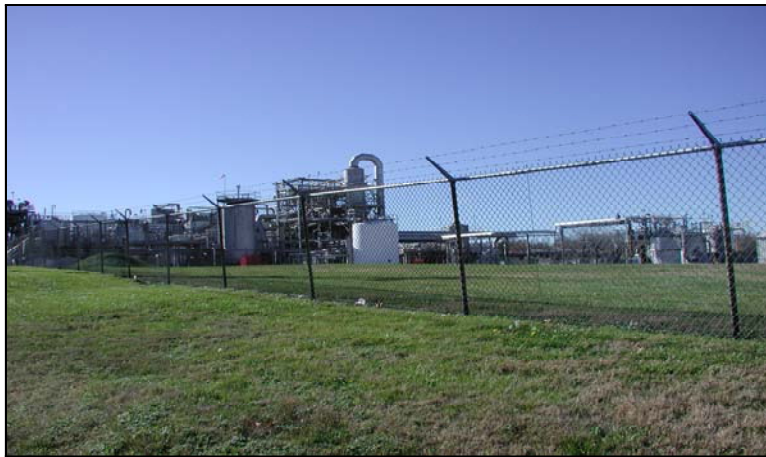
**Photograph 1**

View of industrial property located in  
Theo. Hiertz Metal Co. site area, Primm  
& Alaska Streets. View looking  
southwest.

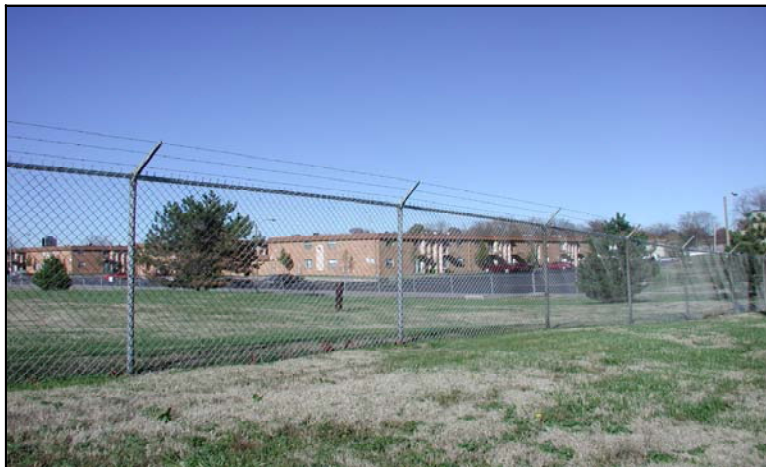
**Photograph 2**

View of neighboring residential property  
located in Theo. Hiertz Metal Co. site  
area, Primm & Alaska Streets. View  
looking northwest.

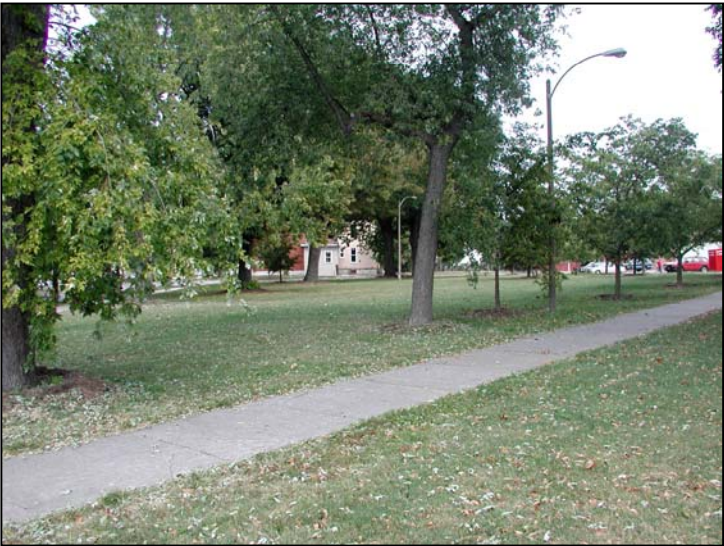
**Photograph 4**

View of So. St. Louis Square Park,  
Sample location 1, Broadway Ave &  
Courtois St. View looking northwest.
